This safety alert was drawn up to spread the lessons learnt from the major oil release of October 25th, 2005 in an oil storage terminal. The oil storage terminal belongs to a large oil company and is an upper tier Seveso establishment.

This alert is based on the investigation of the company, for which several external experts were consulted, and the investigation of the Belgian authorities. After the accident history, this alert gives recommendations to prevent similar accidents in the future.

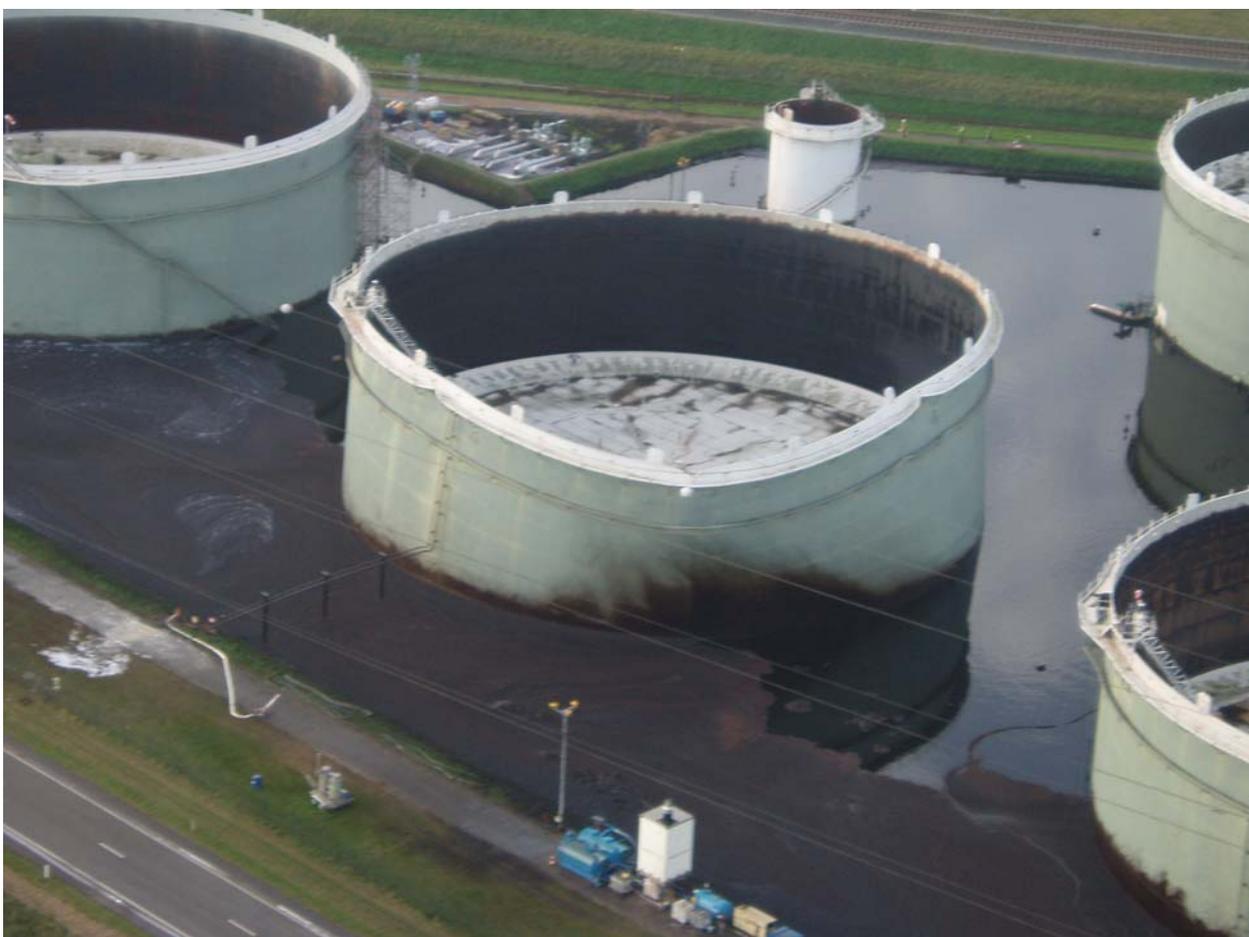
Because the content of the storage tank was released in such a short time, an enormous wave was created. This wave moved in the direction of the several meters high earth dike. Due to the height of the dike only a small amount of crude oil (approximately 3 m<sup>3</sup>) was ejected out of the bund. The released crude oil filled the whole bund (40 000 m<sup>2</sup> large) with crude up to a height of 1 m.

*Figure 2: Picture of the situation in the bund the morning after the major accident*

After the major accident all the crude oil stored at the terminal was immediately pumped to the refinery and the contents of the bund was pumped to the storage tanks D10, D11 and D4 by using the existing drain water pump system. Immediately measures were taken to perform all cleaning activities in the storage terminal in a safe manner.

In the afternoon of October 27<sup>th</sup>, 2005 the major part of the bund was empty. On October 28<sup>th</sup>, 2005 activities were started to reduce the smell. The smell was effectively reduced by covering the entire bund with sand. Where possible the sand layer was placed by trucks and bulldozers. Between the tanks the sand layer was placed by blowing sand in these areas.

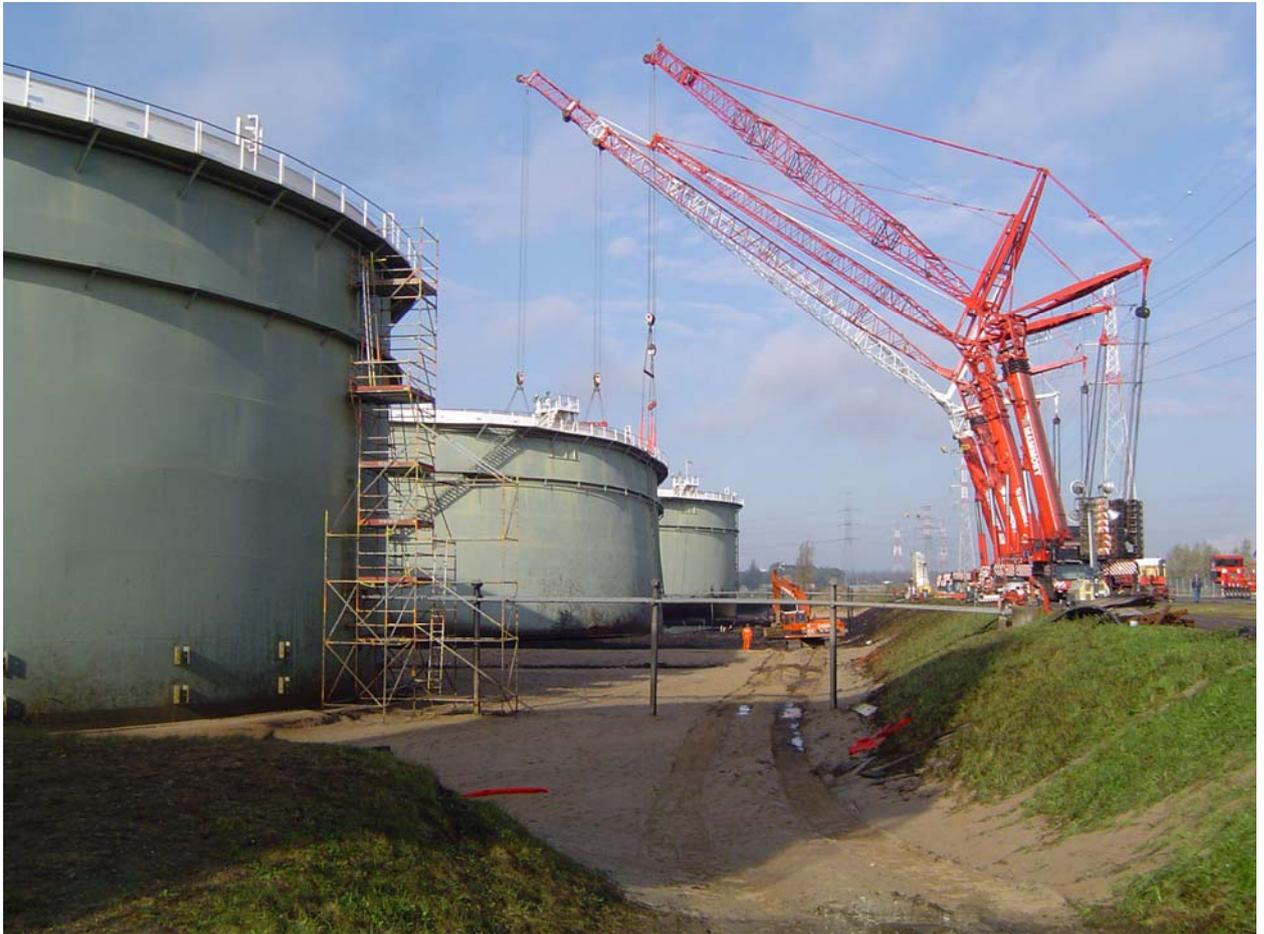
After the release the storage tank was leaning forward and a part of the foundation of the storage tank had disappeared.

The stability of all storage tanks was periodically measured. The stability of storage tank D2 on the place where the foundation was blown away, was achieved by hanging the storage tank on 4 large cranes (figure 3).

*Figure 3: Picture of major cranes stabilising storage tank D2*

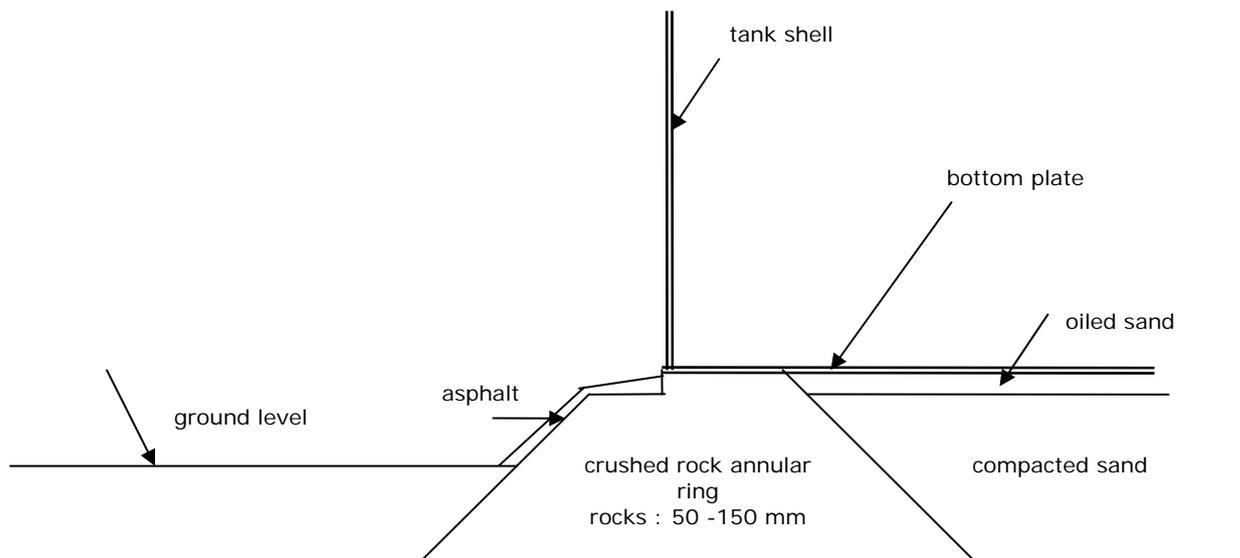
Figure 4: Schematic view of the tank foundation

The foundation of storage tank D2 consisted of a crushed rock annular ring. The rocks had a diameter between 50 mm and 150 mm. The crushed rock annular ring had a height of approximately 120 cm of which a part was below the ground level. The crushed rock ring had a width of approximately 340 cm at the bottom and 100 cm at the top. The shell was situated in the middle of the width of the crushed rock ring. The inner part of the annular ring was filled with compacted sand. Above this sand there was a layer of 5 cm consisting of oiled sand, to avoid external bottom corrosion. Figure 4 provides a schematic view of the foundation of storage tank D2.

The major release initially started with a small leak. Due to this small leak the compacted sand underneath the tank bottom was saturated with oil and a kind of quicksand of oil and sand is formed. This small leak has not been visually detected because the crushed rock annular ring had a lot of holes, which were initially filled with crude oil. In the second phase of the accident the resistance of the foundation under the tank was locally strongly reduced (due to the fluidisation of the sand bed) and due to the hydrostatic pressure of the crude oil on the tank bottom, the bottom has ruptured over the length of the gutter. The force of the out flowing crude oil was that large that it destroyed a part of the tank foundation and swept away part of the underground.

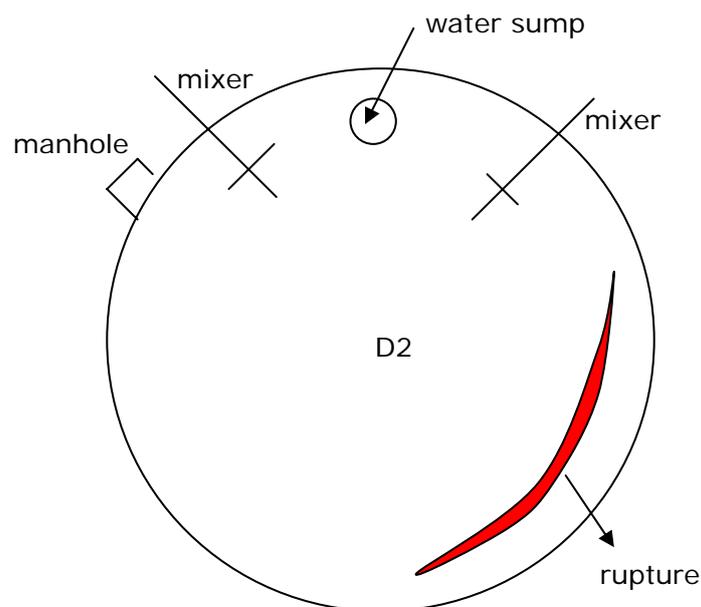
Figure 5 : Schematic view of the bottom of storage tank D2

The investigation of tank D2 showed that the bottom plates in a long, small circular band at approximately 1,5 m from the shell of the storage tank were extremely weakened due to internal corrosion. In this band the thickness of the bottom plates was nearly reduced to zero. This band had a length of approximately 35 m and a width of approximately 20 cm.

In this band the bottom of the tank formed a gutter. In this gutter uniform, internal corrosion was found and no pitting corrosion.

During the exploitation of storage tank D2 a gutter was formed in the bottom of the tank. This gutter is situated at a distance of 1,5 m from the tank shell. Due to the formation of the gutter the present water could not longer flow to the drain water system to be removed. The accumulation of stagnant water in the gutter caused strong corrosion which strongly reduced the thickness of the bottom plates in that area.

As mentioned before, a gutter was situated in the tank bottom at a distance of 1,5 m from the tank wall. This is just beyond the annular plates on which the tank shell is welded. The first normal bottom plates after the annular plates have been teared during the accident. The gutter has been formed due to settlements in the tank foundation, which at that place consists of compacted sand. The gutter has probably been formed during the first hydrostatic tests on the storage tank. The moment a storage tank is loaded for the first time, the compacted sand settles. In the neighbourhood of the crushed rock annular ring, which consists of coarse rocks, it is difficult to compact the sand bed in an appropriate manner during construction. At the moment the storage tank is loaded for the first time, the sand in that area will be more compacted, but because of the existing holes in de crushed rock annular ring a part of the sand will disappear in the holes between the coarse rocks. Due to these phenomena a gutter is formed in the bottom plates nearby the crushed rock annular ring. Calculations based on a finite element method showed that based on the information about the foundation of the tank in combination with the underground under the tank foundation and the size of the storage tank, the forming of the gutter could be predicted.

In the gutter in the bottom of the tank, the present water could not longer flow towards the water sump. This situation of stagnant water in the gutter enabled very fast corrosion in the gutter with the rupture of the tank bottom as the major consequence.

The parts of the bottom plates of the other storage tanks of which the thickness and/or the deformation do not fulfil the prescriptions of API 653 shall be repaired. The foundation of the other storage tanks was investigated to control if they still have enough stability (during the accident they were drawn in crude oil) to restart the exploitation of the storage tanks.

Before start-up all crude oil storage tanks shall be coated with a lining to stop the internal corrosion of the bottom plates.
